# **Friends of Upminster Windmill**

# **Dennis Reports**

## Restoration of the cap and sails

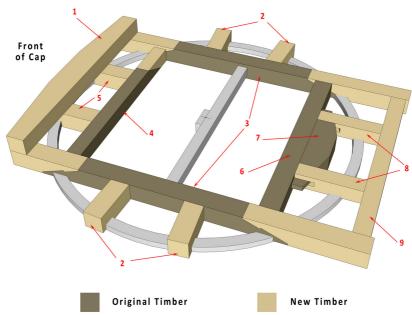
The cap's supporting structure was found to be in very poor condition and much has had to be replaced. However, to retain authenticity, timber replacement is being kept to a minimum. Cliff's second diagram shows how various sections will be either retained or replaced.

- 1. Weather beam. 2. Side horns, or puncheons. 3. Sheers. 4. Headstock. 5. Front, or head mullions. 6. Tail beam (original 1803/5).
- 7. New tail beam (added in 1901). 8. Rear, or tail mullions. 9. Threshold beam.

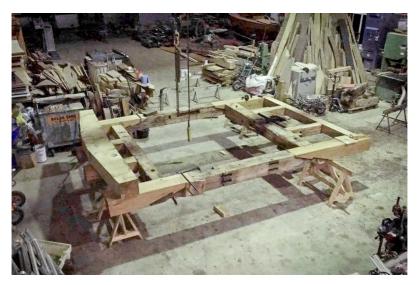
Much of the cap frame is hidden from public view though the central sections of the two sheers and the adjoining headstock and tailbeam (together with its 1901 extension) are visible just above head height on the top floor of the mill. The retention of these sections is therefore key to retaining authenticity. The picture shows how the new wood has been scarfed onto the old.

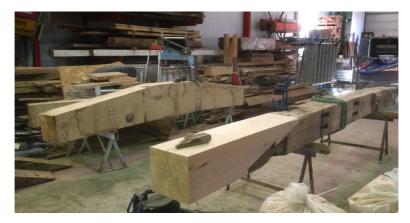
In the foreground is the left sheer with new timber grafted to the front end. The large shaped beam seen behind is the new weather beam, the beam that carries the weight of the sails and windshaft assembly.
