# **Friends of Upminster Windmill**

# **Dennis Reports**

## Restoration of the cap and sails

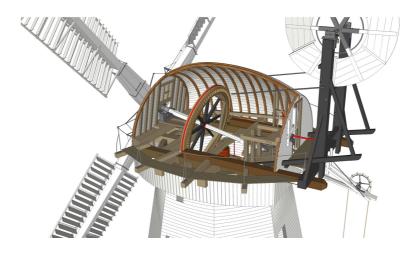
During the year, we reported the removal of the cap and sails from the Mill and explained that they would be refurbished in Willem's workshop in Holland. We also reported on the initial dismantling of the cap and the selection of timber for the repairs. Considerable progress has since been made. Cliff Featherston's electronic model gives us a cutaway view of the timbers and helps us to understand the work that is underway.

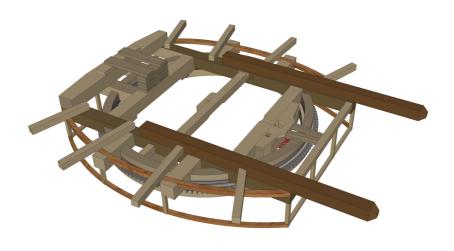
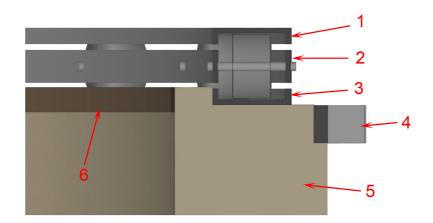
## Key to Curb cross section:

Another of Cliff's illustrations shows how the curb, which sits on top of the smock tower, sits below the cap beams. His model also provides a cross section of the curb, demonstrating how the cap rotates on a series of rollers, which remain invisible once installed.

- 1. Upper section of roller tack mounted to under side of cap circle. 2. Roller Cage.
  - 3. Lower section of roller track mounted on curb. 4. Cast iron gear rack.
    - 5. Timber curb beam. 6. Truck wheel running rail.
