Legionella Risk Assessment

76 Queens Road
Exeter

24-Apr-2015

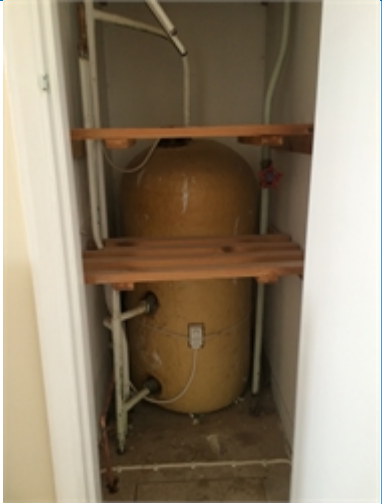
Hot Water System - Risk, Action, Responsibility	Risk Level	Location	Photo
<p>Risk: Water could be stored at too low a temperature</p> <p>Action: Ensure cylinder thermostat is set at 60 degrees</p> <p>Responsibility: Landlord</p> <p>Notes:</p>	Moderate	1st floor Airing cupboard

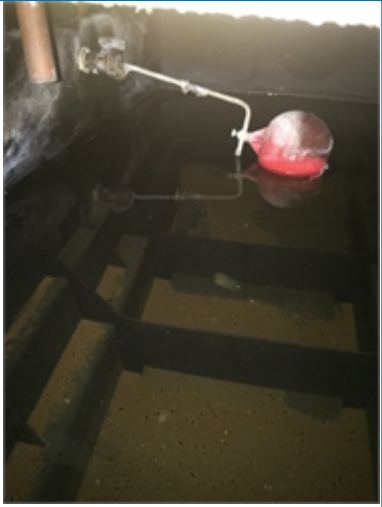
Cold Water System - Risk, Action, Responsibility	Risk Level	Location	Photo
<p>Risk: Supply to cold in bath from cistern in loft</p> <p>Action: Ensure cistern is correctly lagged and has the correct bye law kit fitted</p> <p>Responsibility: Landlord</p> <p>Notes: Cistern has no bye law kit fitted</p>	High	1st floor Bathroom

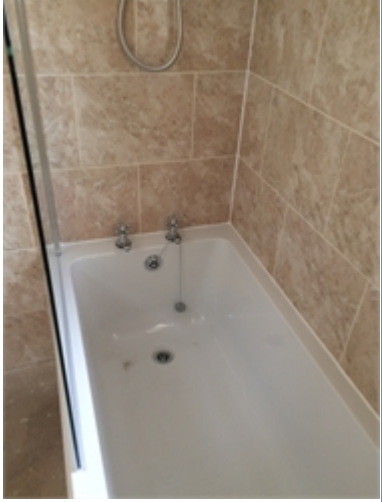
Outlets - Risk, Action, Responsibility	Risk Level	Location	Photo
<p>Risk: Bath cold tap fed via water storage cistern in loft</p> <p>Action: Flush the outlet for 2 minutes every week</p> <p>Responsibility: Tenant</p> <p>Notes:</p>	Moderate	1st floor Bathroom

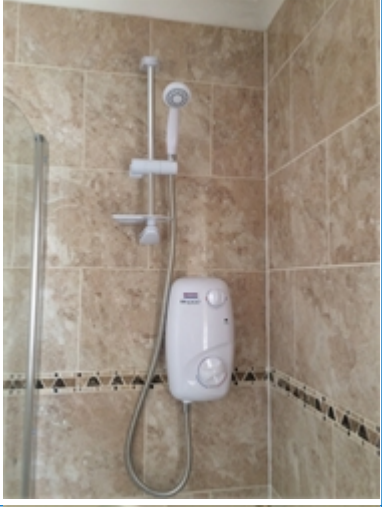
Showers - Risk, Action, Responsibility	Risk Level	Location	Photo
<p>Risk: The shower head of the shower will need regular cleaning</p> <p>Action: The shower head of this shower should be cleaned, disinfected and descaled every 6 months</p> <p>Responsibility: Tenant</p> <p>Notes: Electric shower fed from mains supply</p>	Moderate	1st floor Bathroom

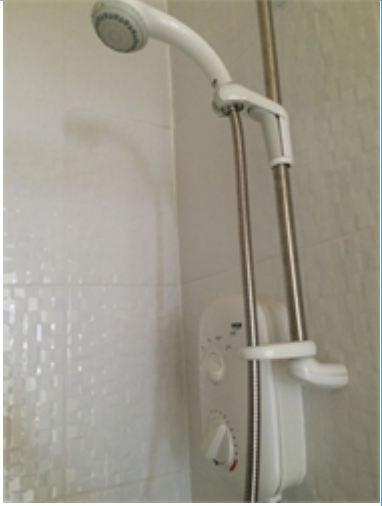
<p>Risk: The shower head of the shower will need regular cleaning</p> <p>Action: The shower head of this shower should be cleaned, disinfected and descaled every 6 months</p> <p>Responsibility: Tenant</p> <p>Notes: Electric shower fed via mains supply</p>	Moderate	1st floor En - suite

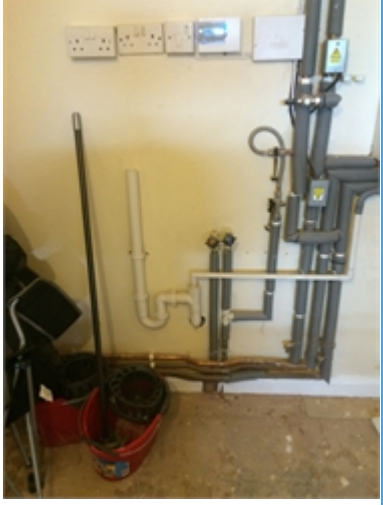
Other Items - Risk, Action, Responsibility	Risk Level	Location	Photo
<p>Risk: Washing machine supply pipe work</p> <p>Action: Ensure used weekly</p> <p>Responsibility: Tenant</p> <p>Notes:</p>	Moderate	Ground floor Garage

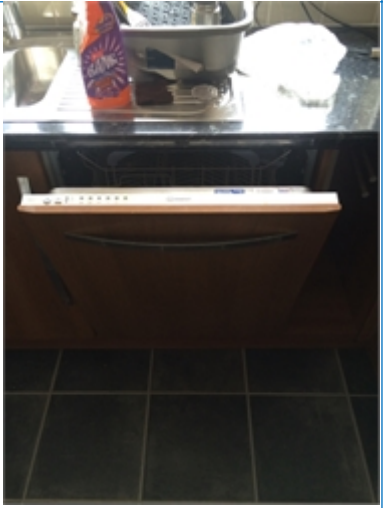
<p>Risk: Dish washer</p> <p>Action: Ensure used weekly</p> <p>Responsibility: Tenant</p> <p>Notes:</p>	Moderate	Ground floor Kitchen
